Odontiatrogenic tooth fracture

Summary. While the awareness of vertical tooth fractures, whether incomplete or complete, is increasing, sufficient attention has not been paid to the manner in which the dentist may contribute to the occurrence of these fractures. This paper focuses on the most likely areas in which the practitioner can either misdiagnose the presence of a fractured tooth or where dental procedures contribute to fracture of the tooth structure. For this type of fracture the authors propose the term 'odontiatrogenic tooth fracture'.

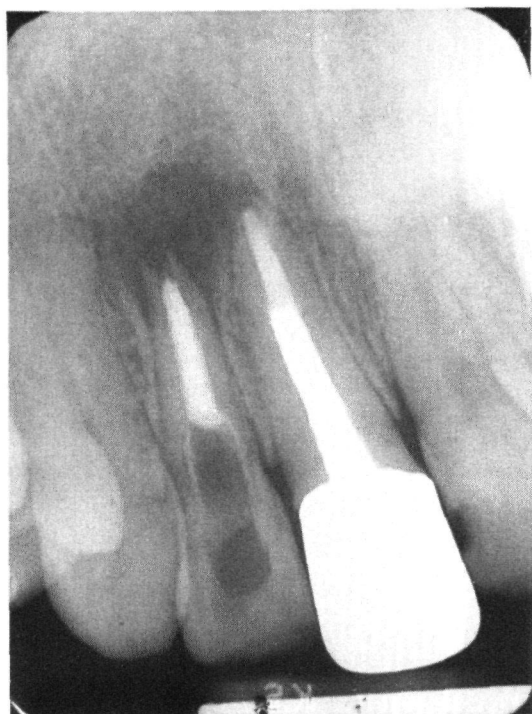
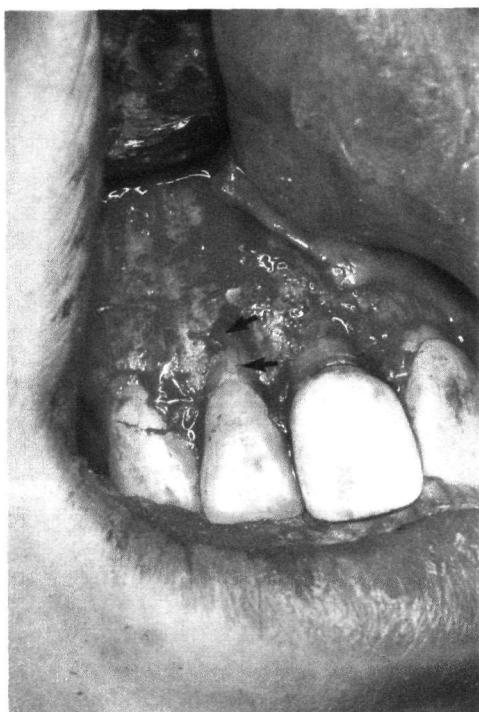
Fig. 4. A radiograph of the maxillary lateral incisor with an open apex and periradicular rarefaction (left); a hint of a radiolucent line can be seen in coronal half of root. Soft tissue reflection (right) reveals a bony defect and vertical fracture (arrows).

exploration should only be used when all other diagnostic means cannot confirm the presence and location of the fracture (Fig. 4). Certainly, in many cases, surgical exploration is indicated before tooth extraction.

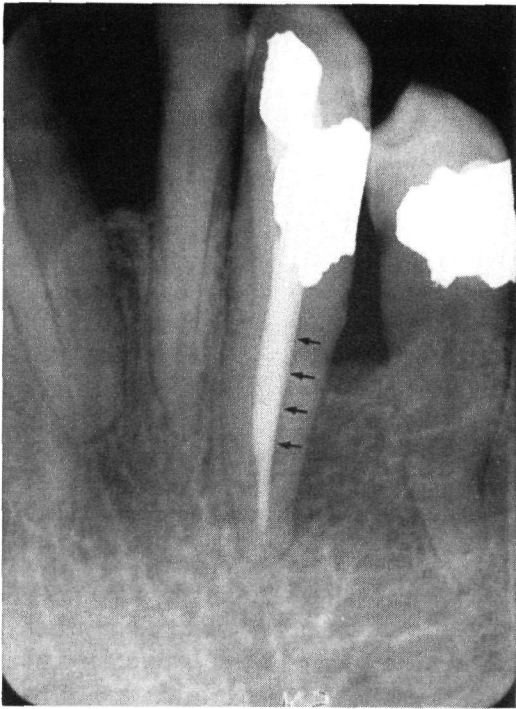
Fig. 6. A radiograph of the mandibular canine which shows diffuse longitudinal bone loss along the distal aspect of the root. Also discernible is a radiolucent line adjacent to the distal margin of the gutta-percha filling (arrows).

indicate a possible vertical root fracture (Fig. 6). A radiolucent line adjacent to the root canal filling material may indicate that there is a space between the root canal wall and the filling material possibly created by a fracture (Fig. 6). This space, however, must be differentiated from a spreader or plugger void. When radiopaque filling material is expressed through the fracture, it may appear on a radiograph as an intensely radiopaque line within the obturated canal (Pitts & Natkin 1983).
