ELECTROLYTIC PRECIPITATION OF ZINC CARBONATE IN THE JAW

An Unusual Complication After Root Resection

Karl-Åke Omnell, Odont. D.,* Malmö, Sweden

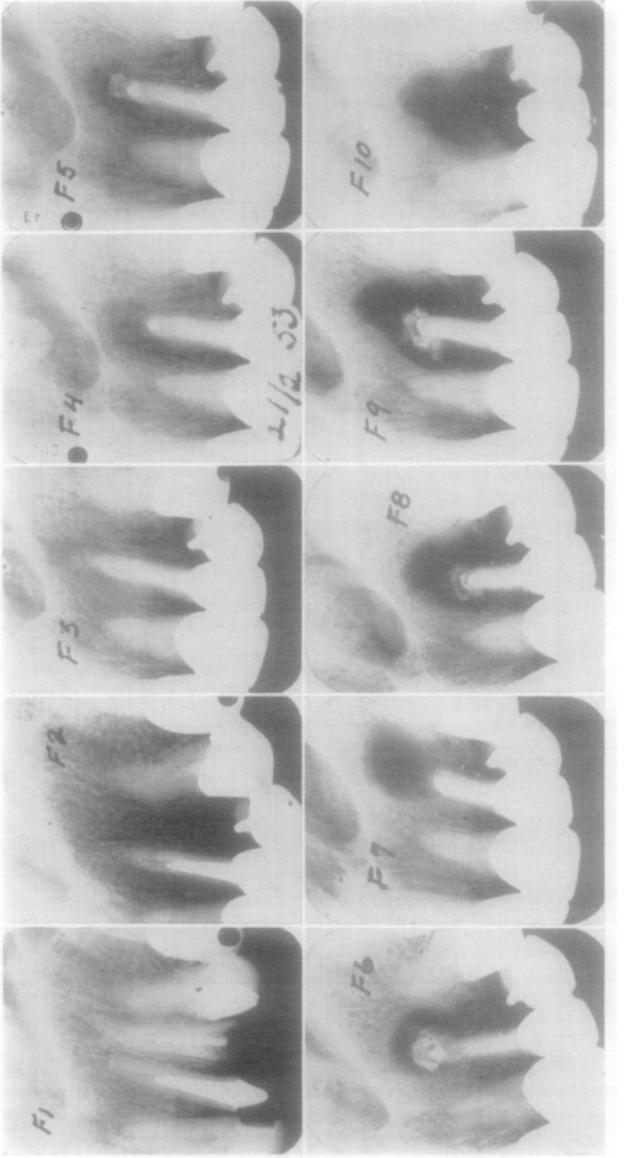
Fig. 1.--No root-filling material visible in the lateral incisor, with the exception of the metal post. There are no signs of osterits around the apex. Feb. 17, 1951.

Fig. 2.—Destruction of the lamina dura at the apex of the lateral incisor. The destruction is most marked mesial to the root. Feb. 6, 1953.

Fig. 3.-Bone destruction around the apex of the lateral incisor and possibly a sequestrum formation at the apex. Feb. 12, 1953.

Fig. 4.--Roentgenogram taken after the operation. Feb. 21, 1953.

Fig. 5.—The apex of the right lateral incisor surrounded by a well-defined bone destruction. There is a roentgenopaque area close to the amalgam filling. May 20, 1953. Fig. 6.—The bone destruction at the right lateral incisor as well as the roentgenopaque area has increased in size. June 15, 1954. Fig. 7.—Roentgenogram taken after the second root resection of the right lateral incisor. June 15, 1954. Fig. 8.—New deposition of roentgenopaque substance at the apex of the right lateral incisor. Sept. 21, 1954.

Fig. 9.—There is still an increase in both the bone destruction and the roentgenopaque formation at the apex of the right lateral inclsor. Jan. 25, 1955. Fig. 10.—Roentgenogram taken after the last operation. Jan. 26, 1955.

In 1952 a fixed bridge was constructed in the upper jaw, extending from the right first molar to the left first molar, with pontics replacing the right canine and the left premolars. Before the bridge was made, the right lateral incisor had a post which was fixed in the root canal by a pin. A roentgenogram (Fig. 1) taken in 1951 shows that there is no root-filling material visible apical to the post and there are no positive roentgenologic signs of periapical osteitis.

The bridge was inserted on Oct. 30, 1952. Some months later, on Feb. 6, 1953, the patient came to the Royal Dental School in Malmö complaining of pain in the front of the maxilla. In the buccal region of the right lateral incisor there was a slight redness of the mucous membrane; a marked tenderness was noted on palpation. There was no swelling or fistula. Roentgen examination revealed destruction of the lamina dura in the periapical region of the right lateral incisor. This destruction was most evident mesial to the apex (Fig. 2).

One week later, on Feb. 12, 1953, the periapical bone destruction had increased but was not so well defined (Fig. 3). Within a small area at the apex, however, the bone showed normal structure, which indicated the formation of a sequestrum.

Fig. 4 shows a roentgenogram taken after the operation on Feb. 21, 1953. Three months later (May 20, 1953), the apex was surrounded by a well-defined roentgenolucent area (Fig. 5). Above, beside, and below the amalgam filling there was a roentgenopaque area which was demarcated against its surroundings. Distal to the root there were two small roentgenopaque fragments (possibly amalgam) near the alveolar crest.

About one year later (June 15, 1954) the destruction had extended further, particularly distally. Its roentgenolucency was more pronounced, indicating that the pathologic area had become limited (Fig. 6). The roentgenopaque area around the apex had also increased and showed greater contrast to the normal bone. The roentgenopaque substance was not homogenic but seemed to be deposited in irregular layers around the apex and the amalgam filling.

Another surgical procedure was undertaken, and the root was resected to the post. The diseased tissues were removed, and a new silver amalgam filling was inserted. The wound was sutured. The extent of the operation is evident from the roentgenogram shown in Fig. 7.

The postoperative course was clinically without complications. Three months later, however, on Sept. 21, 1954, a new roentgenogram (Fig. 8) revealed that bone destruction was still continuing. Close to the amalgam filling there was a small roentgenopaque and homogenic area. Around this area but at some distance from it there was, in addition, some roentgenopaque substance.

A few months later, on Jan. 25, 1955, the destruction had extended toward the alveolar crest and had reached further toward the nasal cavity. The amount of roent-genopaque substance around the apex had also increased (Fig. 9).

In a third operation (Jan. 26, 1955) the whole root and the surrounding supporting tissues were removed. Clinically, no signs of malignancy could be detected. The post-operative roentgenogram is shown in Fig. 10.

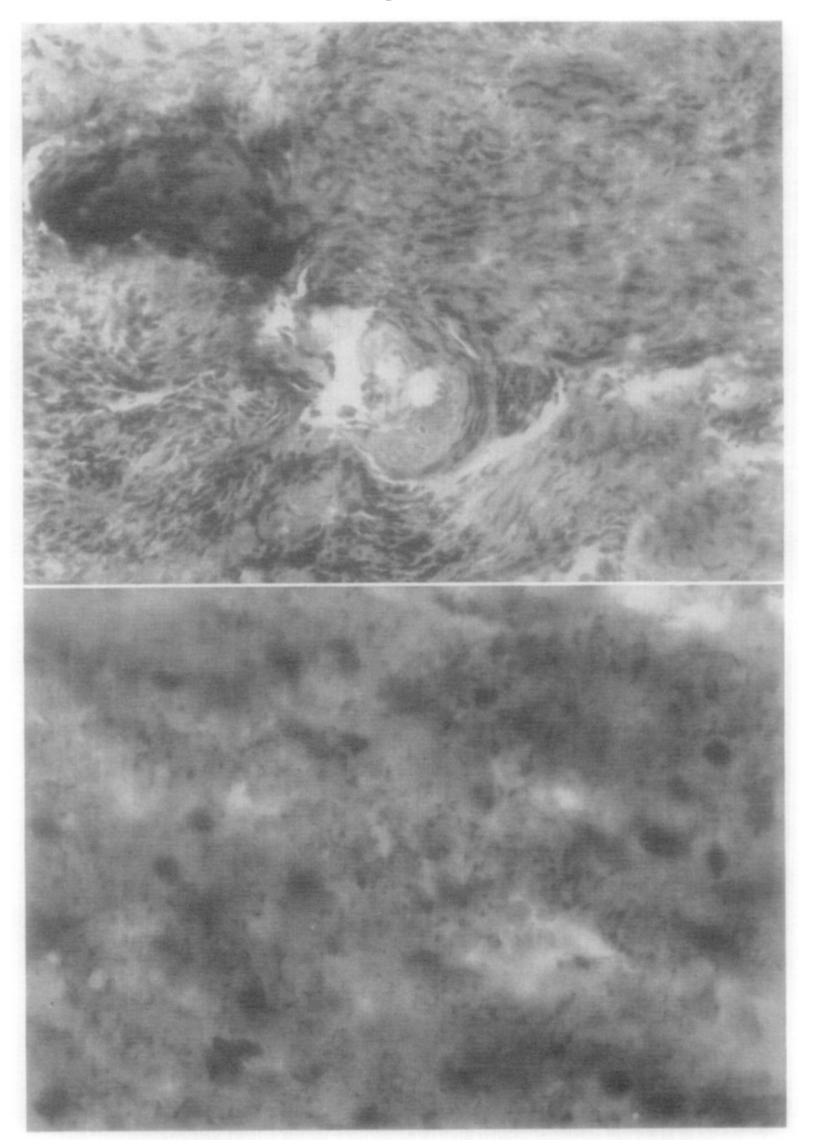
Fig. 11.

Fig. 11.—Areas with hyaline degeneration in different stages of necrosis. (Hematoxylin and eosin stain. Magnification, ×100; reduced ¼.)
 Fig. 12.—Rodlike crystals scattered through the soft-tissue specimen (from the operation of June 15, 1954). (Hematoxylin and eosin stain. Magnification ×400; reduced ¼.)

Histopathologically, there was in both cases a nonspecific inflammation with an invasion of plasma cells and giant cells. Scattered through the tissue were areas of hyaline degeneration (Fig. 11). Around the necrotic areas there was no evidence of foreign body reaction. These pathologic changes were more advanced in the specimen removed at the last operation (Jan. 26, 1955).

In addition to the classical signs of a chronic inflammation, there were, in the specimen removed at the operation of June 15, 1954, numerous small rodlike crystals scattered through the tissue (Fig. 12). These crystals gave a negative response to a histochemical test for iron.

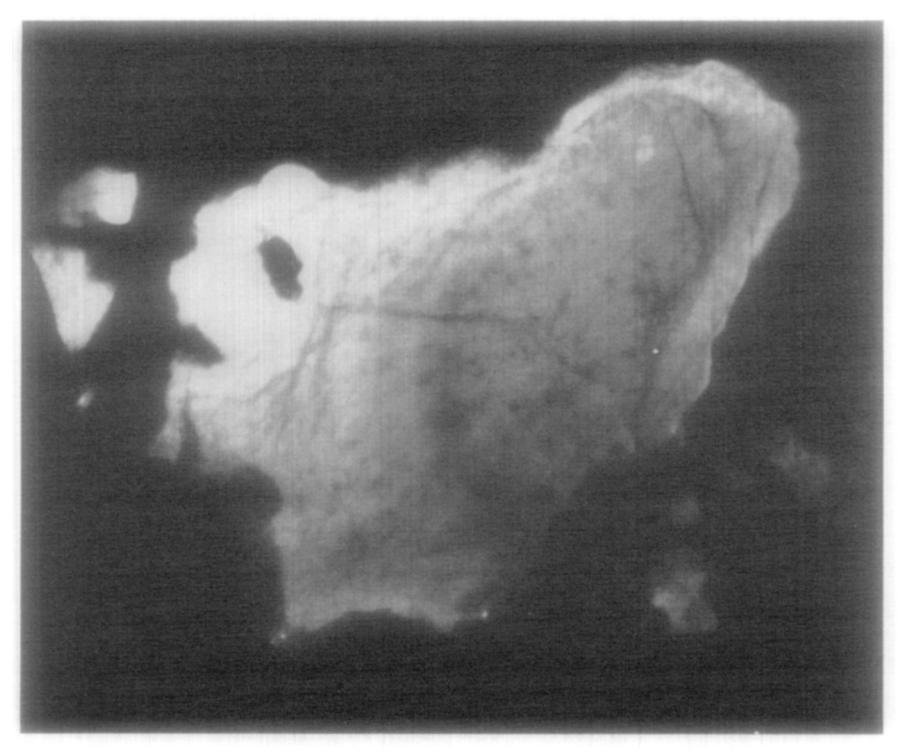
Fig. 13.—Microroentgenogram of a thick section of the roentgenopaque substance 100 μ thick at the apex of the right lateral incisor. Varied roentgen absorption within the specimen but no signs of separate layers. (20 kv., Eastman Spectroscopic Plate No. 649.) (Magnification, X115; reduced $\mathcal{Y}_{4,1}$)

The microroentgenogram of the roentgenopaque substance showed a somewhat "blistered" structure (Fig. 13). Light and dark areas indicate varied absorption of the

roentgen radiation. The absorption seemed to be greatest in the periphery of the specimen. Separate layers or concentrically arranged laminae could not be detected. There were no cell spaces or signs of vascularization.

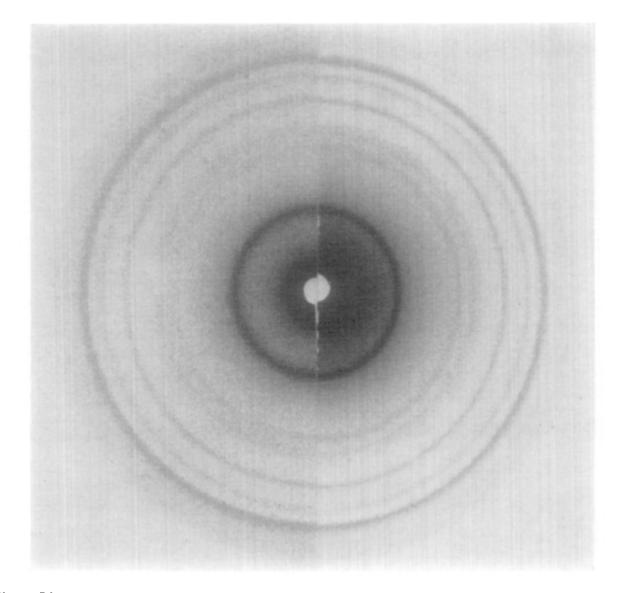
Fig. 14.—Flat-film roentgen diffraction pattern of roentgenopaque substance at the apex of the lateral incisor (left) and from a basic zinc carbonate (right). Note that the diffraction lines correspond in detail. (Ni-filtered Cu-radiation.)

The roentgen diffraction examination of the roentgenopaque substance (Fig. 14) indicated small crystals (about 10-5 cm.) without preferential orientation. The diffraction pattern had no resemblance to those normally found in calcified tissues (hydroxy apatite).

When the roentgen diffraction was recorded on the heated specimen, the well-defined lines in the diffraction pattern could be assigned without doubt to a zinc oxide. With this information, the diffraction lines in the nonheated specimen could be shown to be derived from zinc carbonate.
